Safety Screening Report

Report: 071-75924520-302 **Date:** 09/01/2014

Product: Electrical Socket **ESC Sample Number:** 1

Summary: TÜV SÜD Product Service was commissioned by The Electrical Safety Council to evaluate an Electrical Socket (see figure 1). The aim of the assessment is to assess the product against the clients Safety Screening Test Plan.

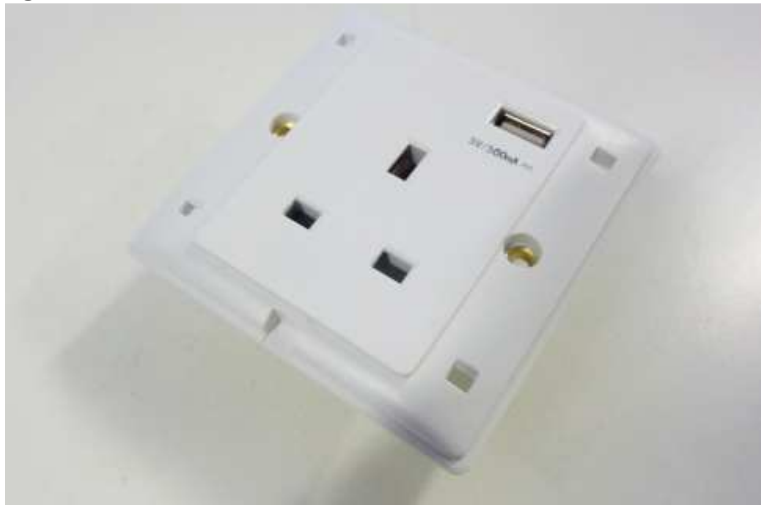
Figure 1

The product was of adequate external construction but it failed to accept several BS1363 plugs. Internal construction was poor and the product had several markings were also missing from the product.

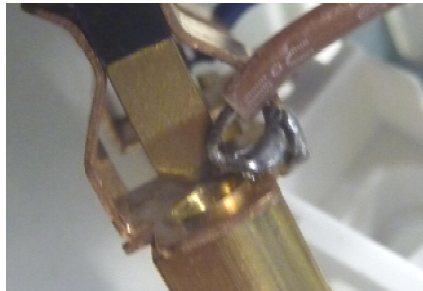
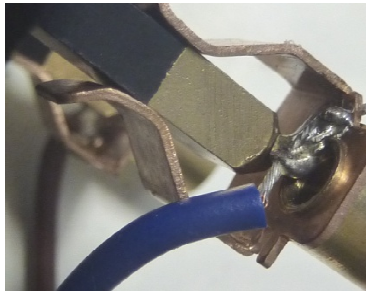
Terminals & Terminations (BS 1363, Clause 11)	
Constructional Quality	<input type="checkbox"/> -Pass <input checked="" type="checkbox"/> -Fail
Comments	A number of BS 1363 approved plugs failed to fully fit into the socket. The input conductors were noted to be adequately secured within the mouldings. Appropriately sized / threaded screws were used.
Internal Wiring / Separation (BS EN 61558-1, Clause 21)	
Constructional Quality	<input checked="" type="checkbox"/> -Pass <input type="checkbox"/> -Fail
Comments	The output (SELV) circuit was separated from the input circuit and covered with boxed moulding which was adequately secured. The Live parts of the SELV circuit were not in direct contact with the protective earth. There was insufficient information on the wiring to enable verification of any 3 rd party approvals.
Screws, Current Carrying Parts & Connections (BS 1363-2, Clause 13)	
Constructional Quality	<input type="checkbox"/> -Pass <input checked="" type="checkbox"/> -Fail

Comments	<p>The connections to the PCB were found to be mechanically secured and soldered; however the connecting wires were tack soldered directly into the live / neutral conductors which prevented full insertion of the plug pins. It is recommended that connections of this type are mechanically secured in addition to soldering and situated as to not interfere with other connections.</p> <div style="display: flex; justify-content: space-around;">

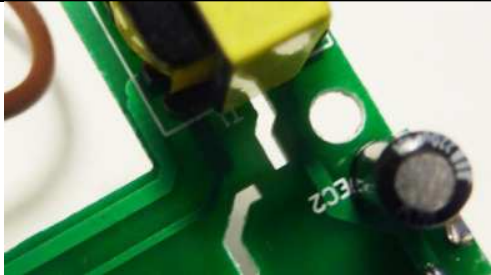
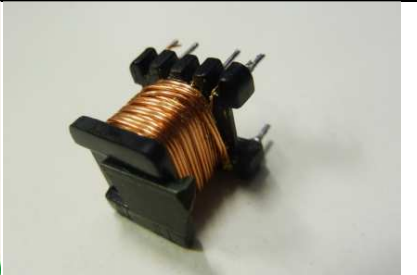
</div>
Creepage Distances, Clearances & Distances Through Insulation (BS EN 61558-1, Clause 26)	
Constructional Quality	<input type="checkbox"/> -Pass <input checked="" type="checkbox"/> -Fail
Comments	The minimum creepage distance measured between the primary and secondary side of the circuit board was found to be within the limit; however a clearance distance of 2.25mm was measured. Although there was the addition of a 1mm slot, it did still did not meet the minimum requirement of the standard. There was no measurable distance between the primary and secondary transformer windings (touching). The standard requires a minimum of 5mm in both instances.

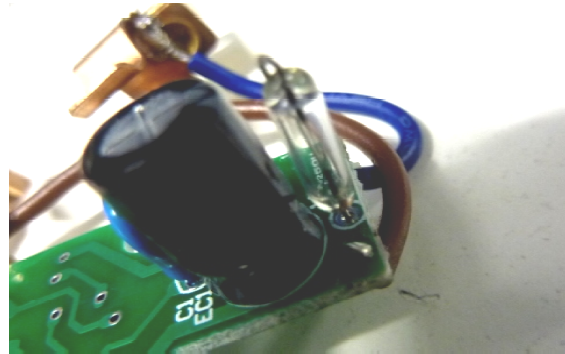
Fuse

Short Circuit, Overload and Thermal Protection (BS EN 61558-1, Clause 15)		
Constructional Quality	<input checked="" type="checkbox"/> -Pass <input type="checkbox"/> -Fail	
Comments	A 1A, glass fuse was suitably fitted to the primary side of the circuit. There was no thermal protection present. Although not a requirement it is recommended that a thermal link is incorporated into the circuit.	
Mechanical Strength (BS 1363-2, Clause 20)		
Result	<input checked="" type="checkbox"/> -Pass <input type="checkbox"/> -Fail	
Comments	Standard USB connectors were placed into each socket,. These and areas around the fascia and USB port were subjected to an impact test of 5Nm. Some deformation of the socket's metal casing was noted; however this did not affect the mechanical fit of a USB plug.	
Insulation Resistance / Leakage Current (BS EN 61558-1, Clause 18.2)		
Result	<input checked="" type="checkbox"/> -Pass <input type="checkbox"/> -Fail
