# Safety Screening Report

**Report:** 071-75924520-701 **Date:** 18/11/2013

**Product:** Electrical Socket **ESC Sample Number:** 4

**Summary:** TÜV SÜD Product Service was commissioned by The Electrical Safety Council to evaluate an Electrical Socket (see figure 1). The aim of the assessment is to assess the product against the clients Safety Screening Test Plan.

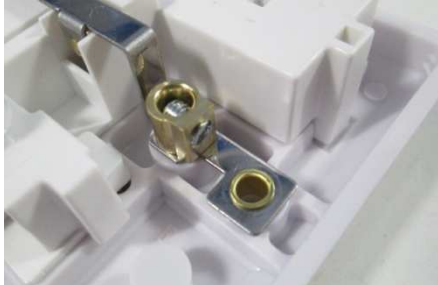
<b>Terminals &amp; Terminations (BS 1363, Clause 11)</b>	
<b>Constructional Quality</b>	<input checked="" type="checkbox"/> -Pass <input type="checkbox"/> -Fail
<b>Comments</b>	A number of BS 1363 plugs could be inserted fully into the socket with no issues found. The input conductors were well constructed in brass.

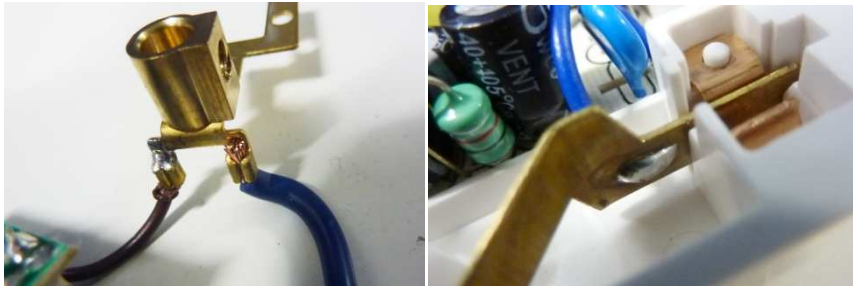
<b>Comments</b>	The connections to the PCB were found to be mechanically secured and soldered. The input and output conductors were adequately secured within the mouldings. The connections from the PCB were secured to the output conductors by crimping / soldering or mechanically securing / soldering.

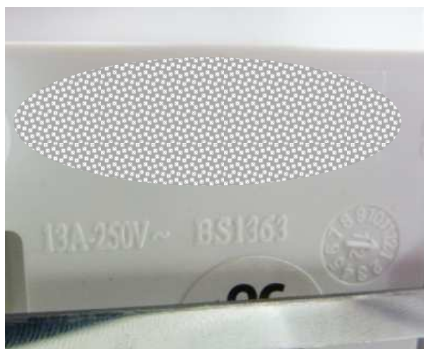
**Markings**

The product was of an adequate standard externally and internally. Markings were poor as they could be rubbed off the facia very easily. Several markings were also missing from the product. The product failed to meet its stated current limit of 1.2A by only managing an output of 0.74A .

Findings	
Markings/Warnings (BS 1363-2, Clause 7)	
Marking of Product	<input checked="" type="checkbox"/> -Inadequate <input type="checkbox"/> -Poor <input type="checkbox"/> -Adequate <input type="checkbox"/> -Good <input type="checkbox"/> -Very Good <input type="checkbox"/> -N/A
Comments	<p>The product was marked with model reference, distributor name, BS 1363 and the sockets electrical ratings. The USB's electrical ratings were printed on the front face; however this could be removed by just rubbing by hand. No regulated rub test was carried out as it was deemed un-necessary. The WEEE logo and CE marking were also missing from the product and packaging.</p> <p>An instruction leaflet was provided which included an adequate amount of information regarding the products technical specification and installation. Both the packaging and instructions stated that the product was suitable for mobile phones, Blackberry, iPods, iPhones, PDA's and MP3's. A statement advising the user that the product will trip should the current exceed 1.2A was also noted.</p>

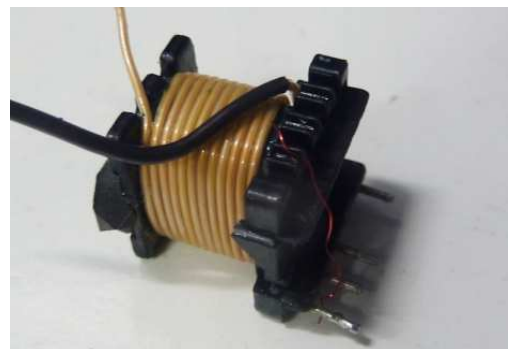
**Transformer**

<b>Creepage Distances, Clearances &amp; Distances Through Insulation (BS EN 61558-1, Clause 26)</b>	
<b>Constructional Quality</b>	<input type="checkbox"/> -Pass <input checked="" type="checkbox"/> -Fail
<b>Comments</b>	A minimum creepage / clearance distance of 3.3mm with a 1.9mm slot was measured between the primary and secondary sides of the circuit board, meeting the requirement of the standard (>5mm). The transformer was constructed with a sleeved / triple insulated winding therefore providing an adequate barrier from the primary winding.
